Farabaugh Engineering and Testing Inc.

AIR LEAKAGE TEST

12" GREENSEAM PLUS HVAC PIPE

GREENSEAM INDUSTRIES
210 5TH STREET
CHARLEROI, PA 15022

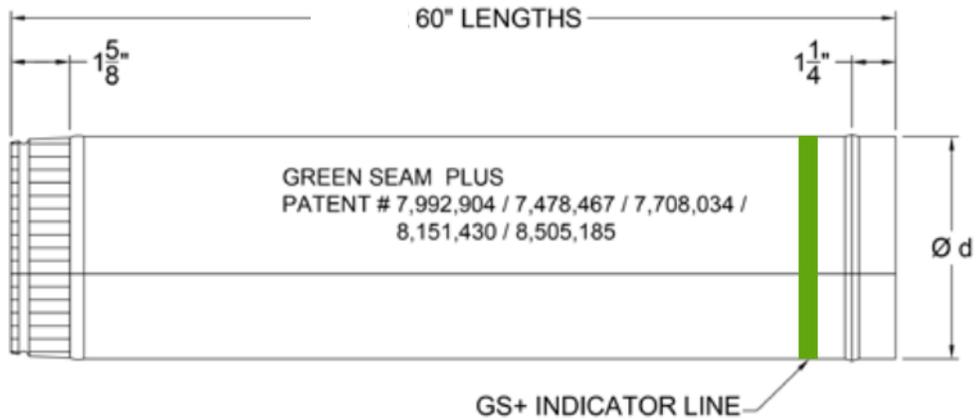
Specimen: GreenSeam Plus Pipe, 12” dia. X 26 ga Circular Duct

Test Pressure (Inches of H2O)	TEST #1 (CFM)	TEST #2 (CFM)	TEST #3 (CFM)	TEST #4 (CFM)	AVG (CFM)	CLASS
0.5	1.124	0.168	0.773	0.759	0.706	2.82
1	1.668	0.555	1.077	1.018	1.080	2.75
2	1.992	0.571	1.592	1.165	1.330	2.16
4	2.440	0.935	1.311	1.797	1.621	1.68
6	2.825	1.188	1.439	2.385	1.959	1.56
8	3.989	1.428	1.580	2.741	2.435	1.61
10	3.596	1.544	1.606	2.767	2.378	1.36

The tests were conducted using a blower to induce a positive pressure inside the duct mock-up. A laminar flow element was used to measure the air flow at various pressures. The duct joints were taped off to determine the air leakage in the set-up apparatus. Additional air leakage readings were taken at the various pressures with the tape removed to determine the air leakage through the duct mock-up. The air leakage values reported here-in are the net air leakage values (Total Air Leakage minus Set-up Apparatus Leakage).

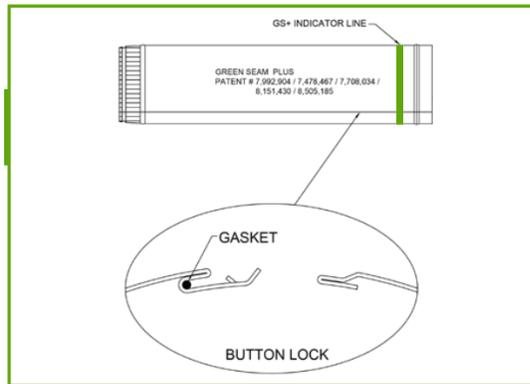
Longitudinal Gasket Composition

This material is made of butyl and E.P.D.M. rubbers, and proprietary co-polymer. It contains some process aids, antioxidants, tackifying resins, and is fungi resistant.

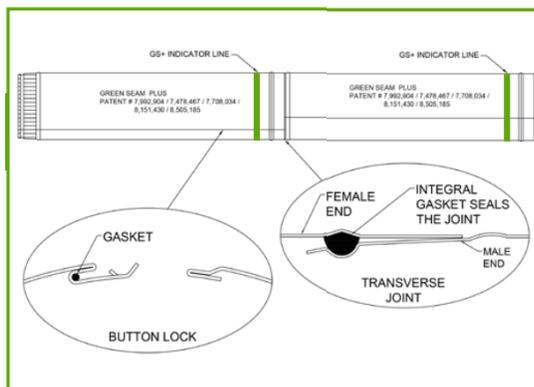
Transverse Gasket Composition

This material is a two-component polyurethane foamed gasket. The gasket is liquid applied directly onto the pipe by using FIPFG (formed-in-place foam gasket) technology. This produces a flexible tack-free foam gasket.
